Title: Skeam Island Church

Author: Fahy, E. M.

Journal of the Cork Historical and Archaeological Society, 1962, Vol. 67, No. 206,
page(s) 138

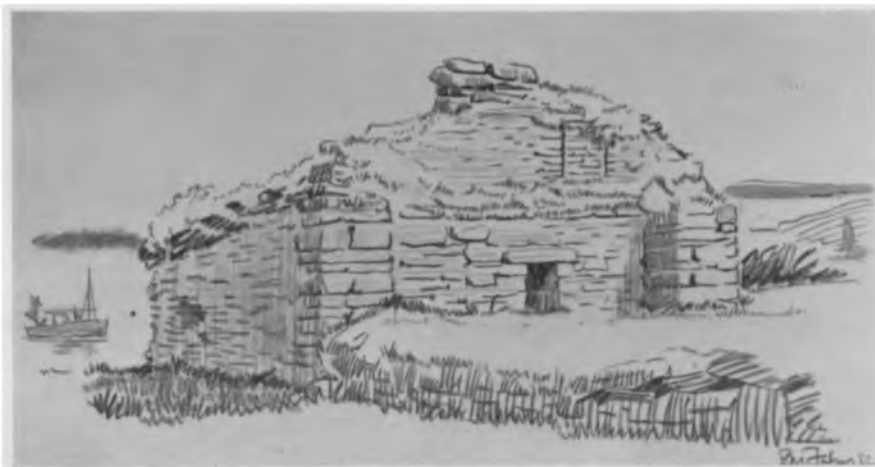
(a) Skeam West church seen from the north-west

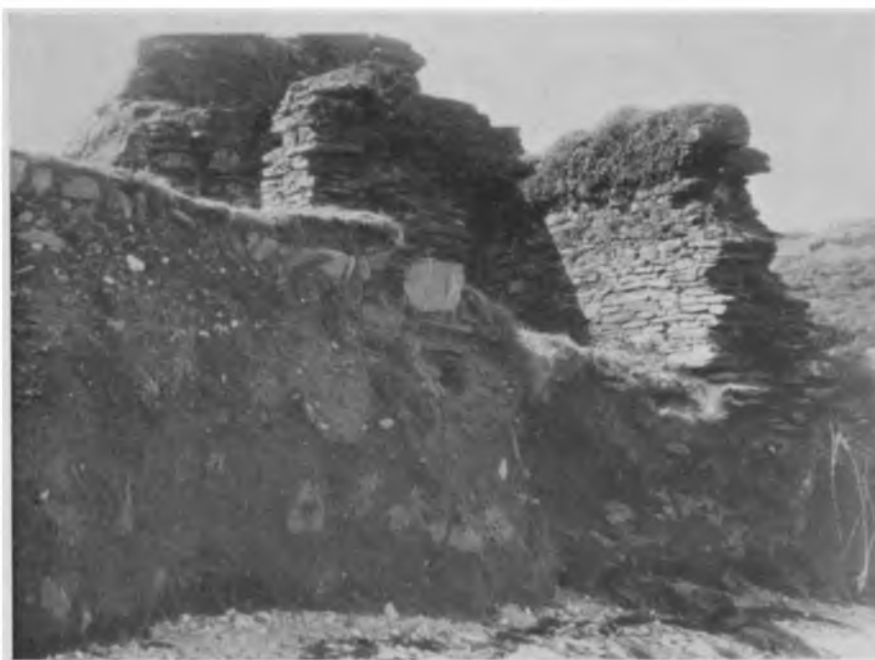
The Skeam Islands, East and West, lie on the southern side of Roaringwater Bay and close to the mainland at Fasagh, near Aghadown, Co. Cork. The church ruin, which was first brought to my notice by Mr P. O'Keeffe of Bantry, stands on a seven foot high cliff of boulder clay on the eastern end of Skeam West. High water of Spring tides reaches the foot of the cliff and the eastern gable of the church has long since fallen into the sea. The ends of the long walls overhang the cliff edge and are steadily collapsing as the cliff is eroded away. However, about three-quarters of the building, including the western gable, remains.

The architectural features of the church, drystone building, simple doorway with inclined jambs and without architrave, the antae and the estimated length/breadth ratio of the interior suggest a ninth century date for the structure. It is to be regretted that this, the only church of its date in the area is to be allowed to crumble into the sea.

(b) Skeam West church—view from the eastern beach showing the low boulder clay cliff on which the ruin stands

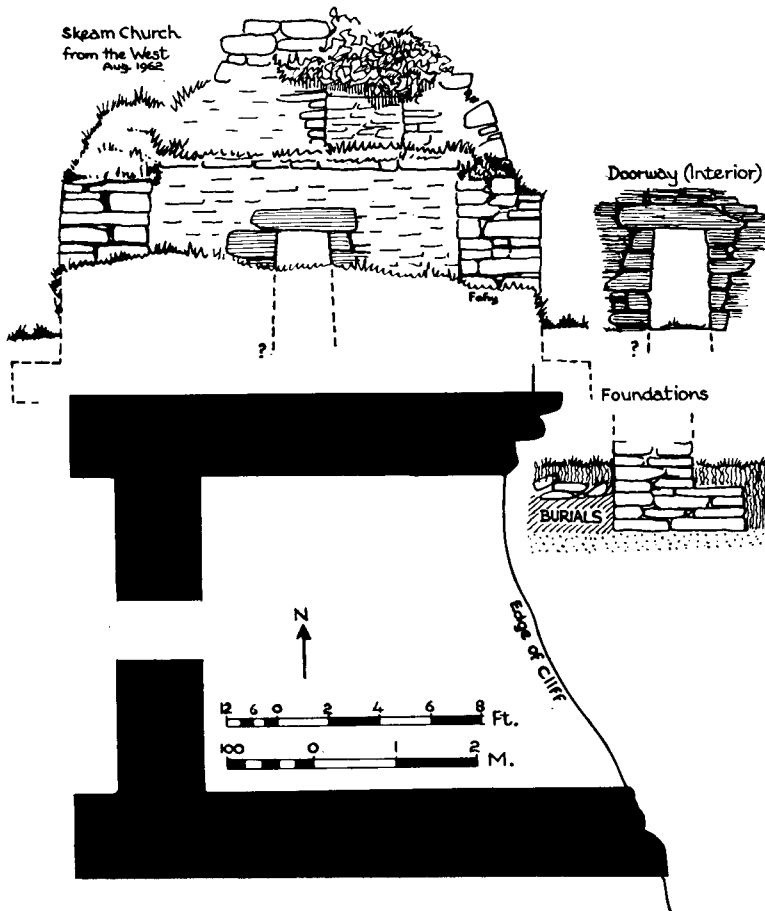
The principal architectural features of the building are a well built doorway with square head and splayed jambs, bold antae which project $20\frac{1}{2}$ " beyond the western gable, a 9" wide offset on the south wall and a similar offset across the western gable at a point 3' 6" above the door lintel. An unusual feature is a rectangular opening, now built up, measuring 3' 6" wide by 3' high, above the offset in the western gable. It is partially obscured by ivy and other vegetation and without clearance it is not possible to say with any certainty what its purpose was. It may be an insertion done when a building was added to the western gable—a building which has now collapsed to the ground. A hamlet which lay to the south of the church is also in ruins for some time.

The interior of the church is 12' 7" wide and its maximum existing length is 17' 6". The long walls are 3' 2" and 3' 4" thick on north and south respectively. The west gable is 3' 3" thick. The doorway is 2' 4 $\frac{1}{2}$ " wide at its base and narrows to 2' 0 $\frac{1}{2}$ "; at the lintel. The gable stands to a height of 11' 10" and where well preserved on its southern side shows the usual 'upturned boat' profile springing from the level of the offset. The northern wall has an inward batter of 2" in 7' 6" and has a patch of plaster on its inner face. At foundation level the bases of the walls expand to a thickness of 5' 2", of which the footing, to the outside of the building, measures 1' 10" wide and 1' 7" deep.

Skeam West church—western elevation, plan and details.
